Stanford Heritage Committee

14 June 2018

Proposed Plan of Works for Renovations and Repairs to the Buzzy Beez building, Erf 101, Church Street, Stanford

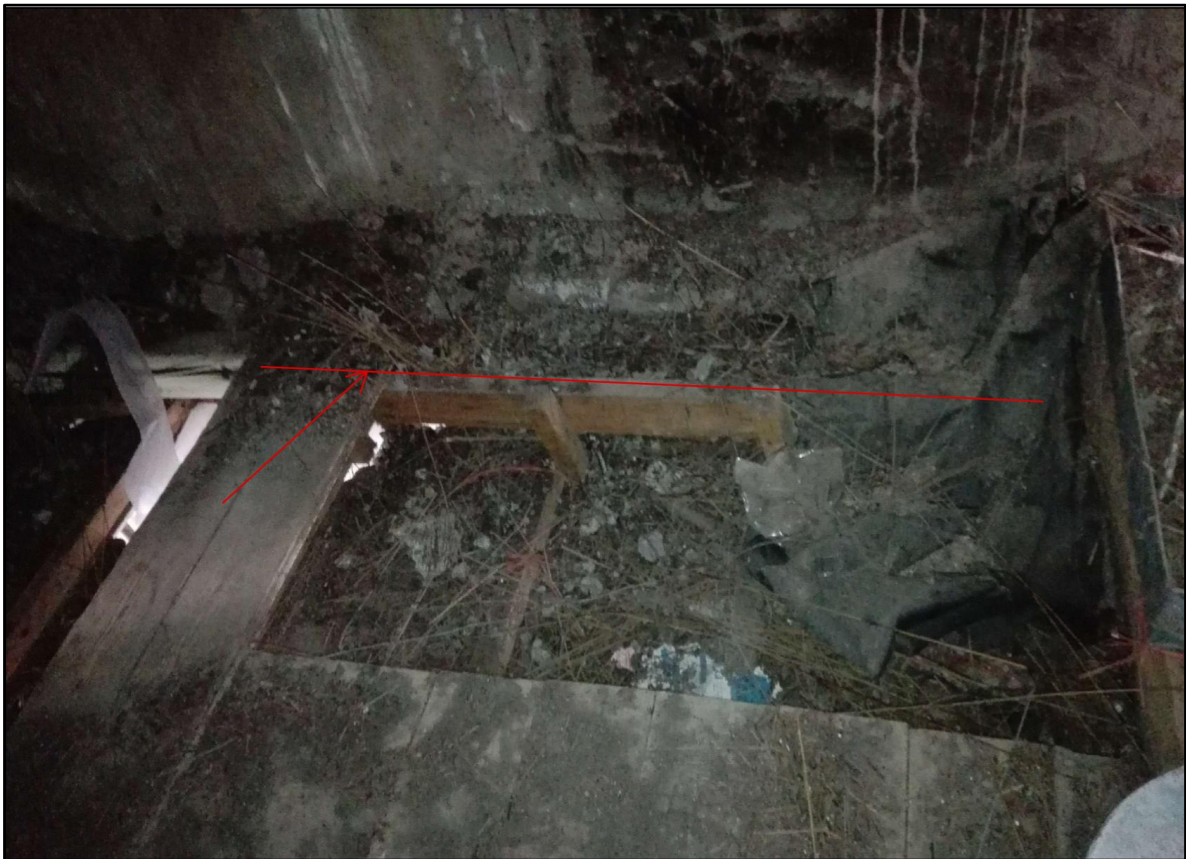
Figure 1: Truncated tie beam at northern end of building where original fireplace was located.

1. **Repair of the roof structure at the northern end of the building.** The northern end of the building originally had a hearth/fireplace with a flue that exited through the roof below and west of the ridgeline (Figure 1). To accommodate this flue, the northern end tie beam, collar tie and rafter were truncated (Figure 1, 2 and 3). This flue has subsequently been dismantled, and these three elements of the roof structure need to be repaired, in the case of the tie beam, and replaced, in the case of the collar tie and rafter.

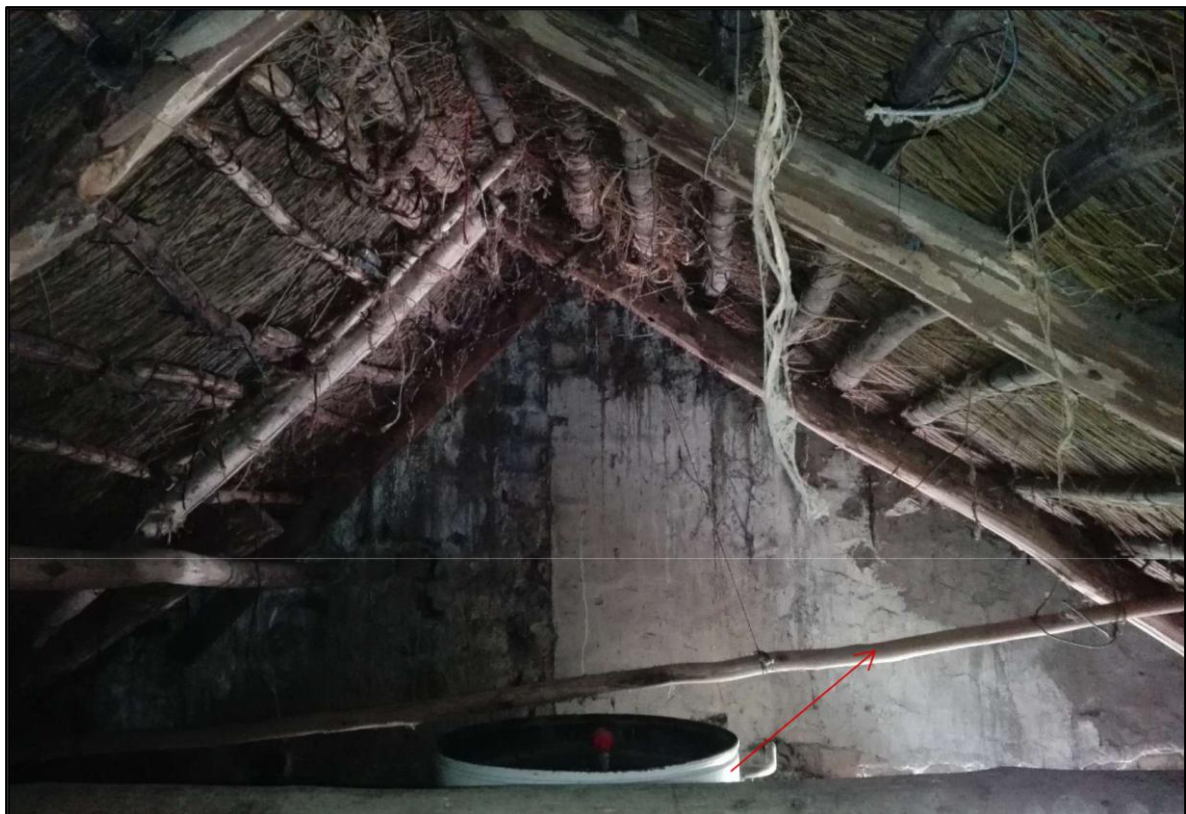
Figure 2. Damaged collar tie at northern end of building. Blackened plaster shows location of original chimney.

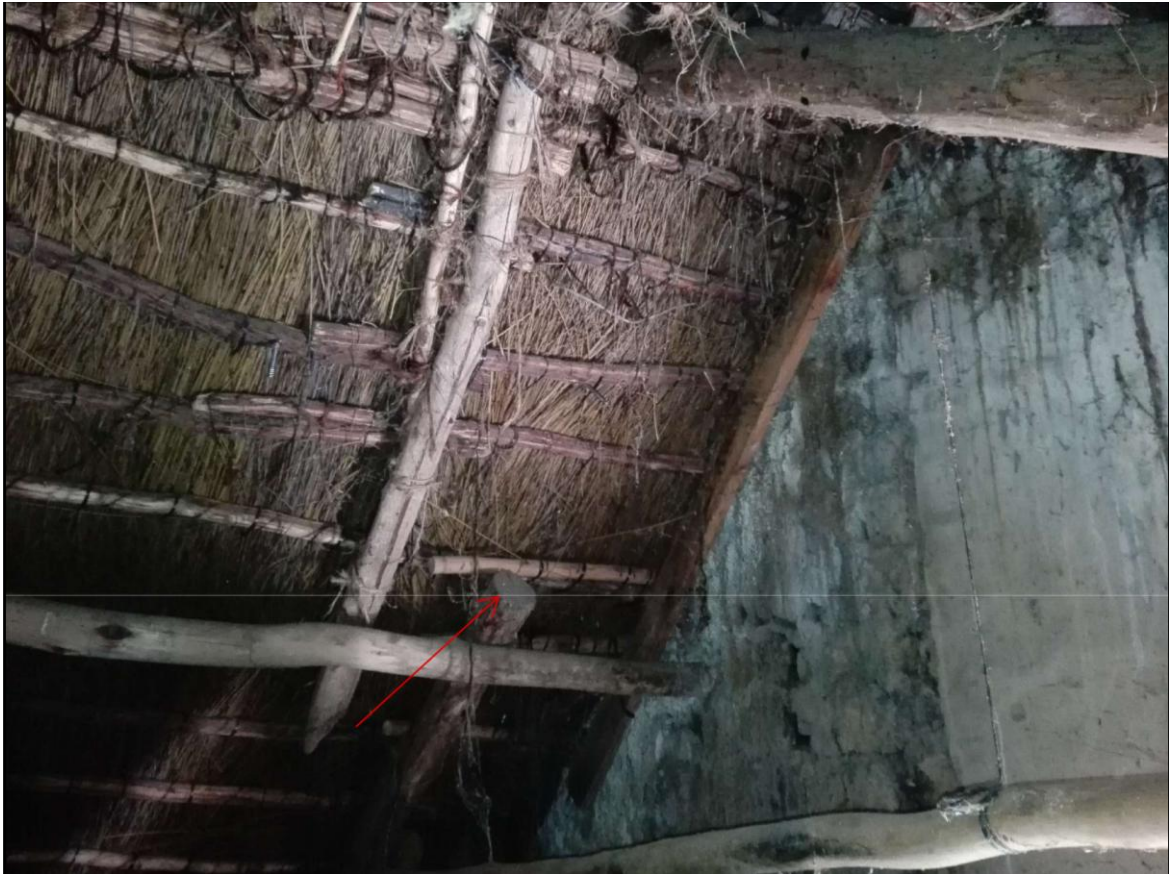
Figure 3. Truncated rafter at northern end of building.

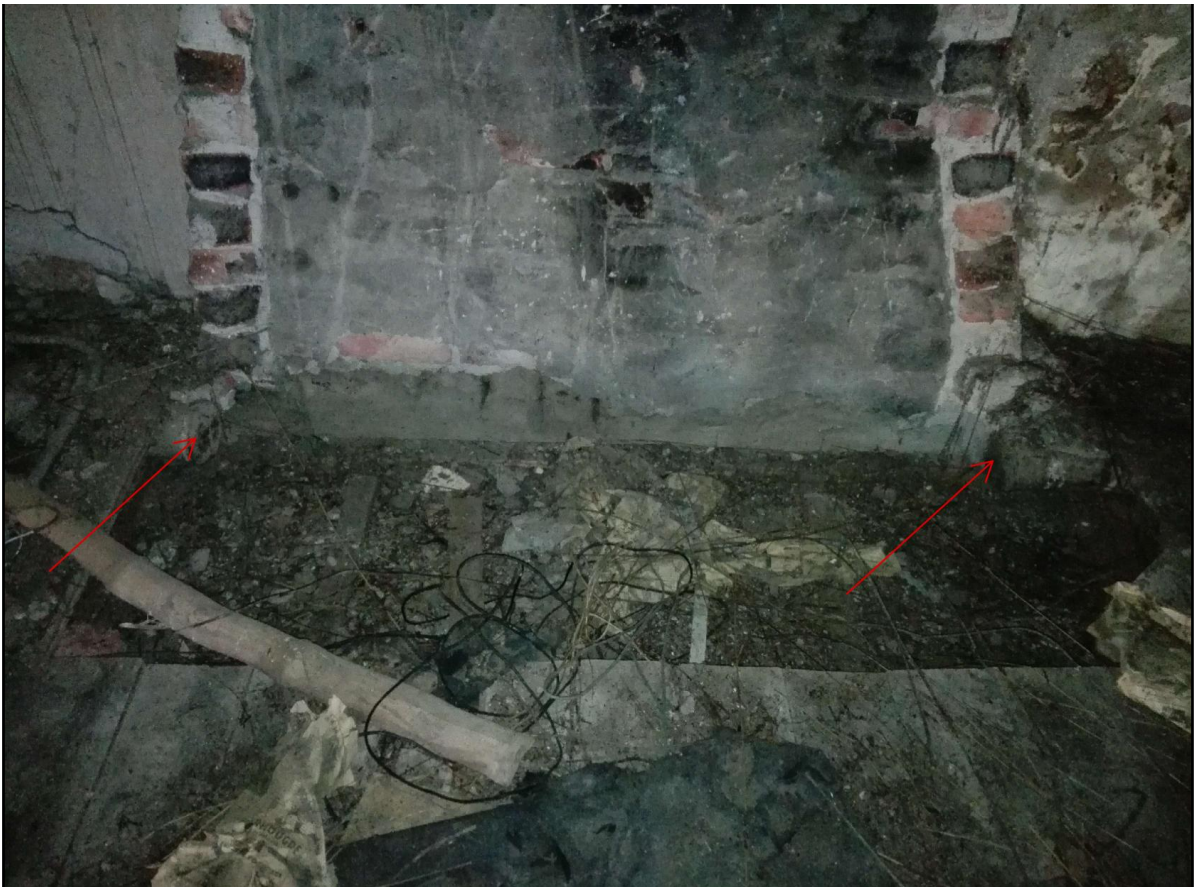
Figure 4. Truncated tie beam at southern end of building. Brick-built chimney of later fireplace visible.

2. **Repair of the southern tie beam.** The southernmost tie beam was truncated by the later installation of a fireplace in the southern end of the building (Figure 4). The chimney of this fireplace was built up through the ceiling, blocking a small window, door or ventilation aperture in the southern gable end. The exit point through the roof is no longer apparent as the fireplace was dismantled and the the structure reroofed subsequently.

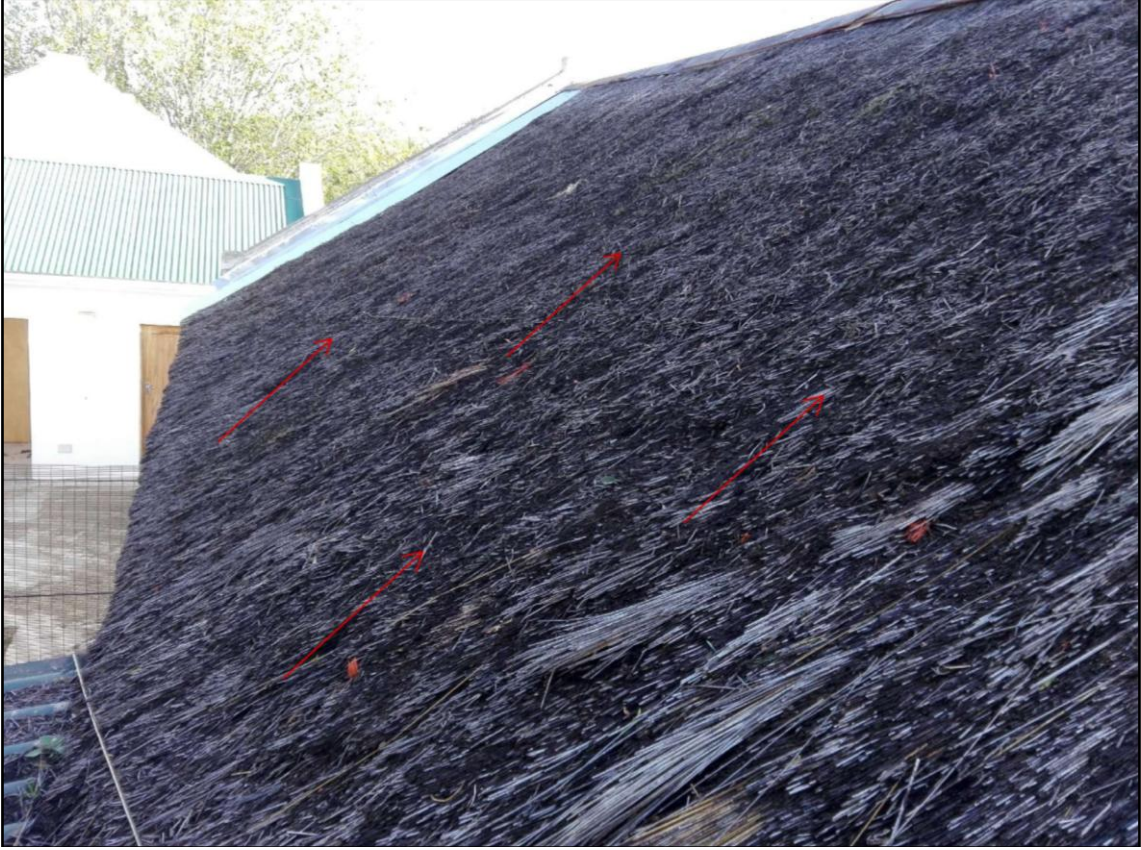
Figure 5. Degraded thatch to be replaced or patched.

4. **Rethatching.** Funds are currently being raised to allow for the rethatching of the building. Should fundraising efforts not be successful, the thatch will be patched rather than completely replaced (Figure 5). The existing metal ridge capping to be replaced with appropriate plaster capping (Figure 6). The thatching is to be done by a local thatcher with experience of similar structures in Stanford Village.

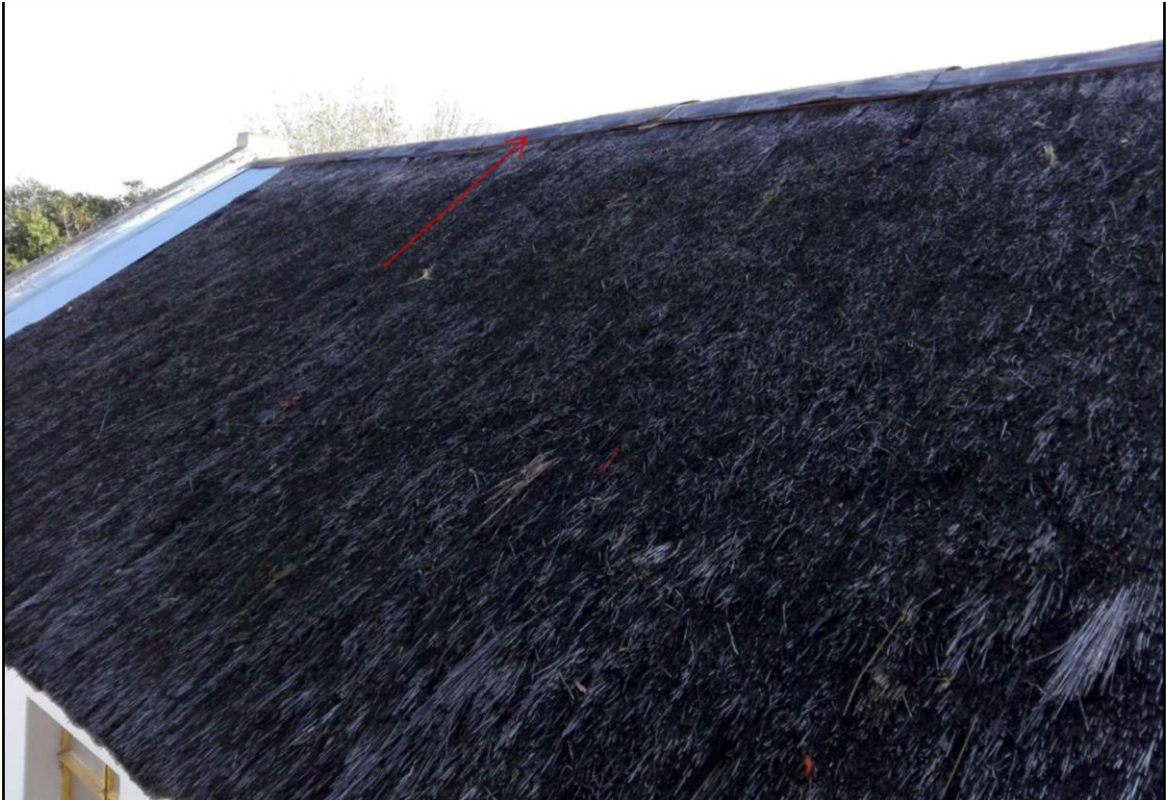
Figure 6. Metal ridge capping to be replaced with cement/plaster capping.

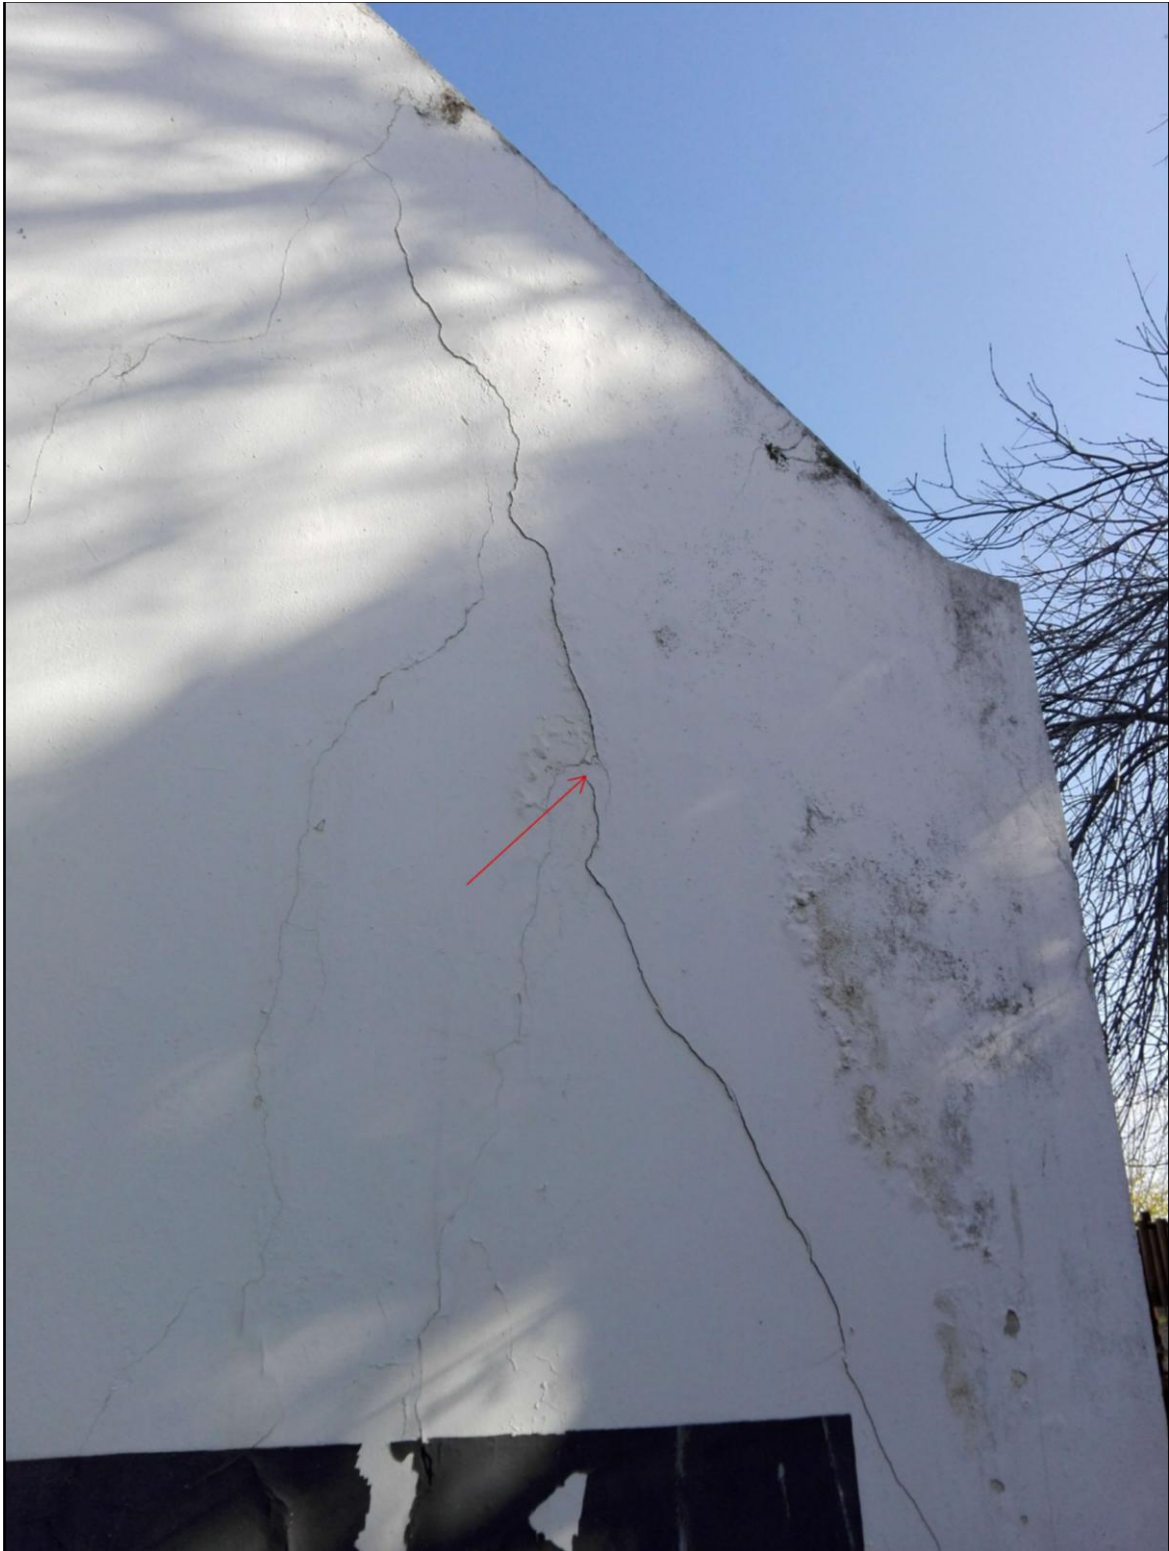
- The cracks on the southern gable end run up-down with no apparent cause, apart from the cracks at the eastern end that may have developed due to settlement of the foundation on the south west corner.

Figure 7. Cracks in plaster at southern end of building requiring repair and repainting.

5. **Replastering of failed exterior plaster.** Where plaster has failed on the structure (Figures 7 and 8), this will be repaired or replaced as necessary. External plaster is to be two coat, wood float finished, and to be kept damp or wetted for one week to reduce risk of wind cracks. Plaster mix to be 1:1:8 (1 part cement, 1 part lime, and 8 parts sand). An approved waterproofing compound (e.g. Congrim powder) is to be added to the mix in proportion as specified by the manufacturer.

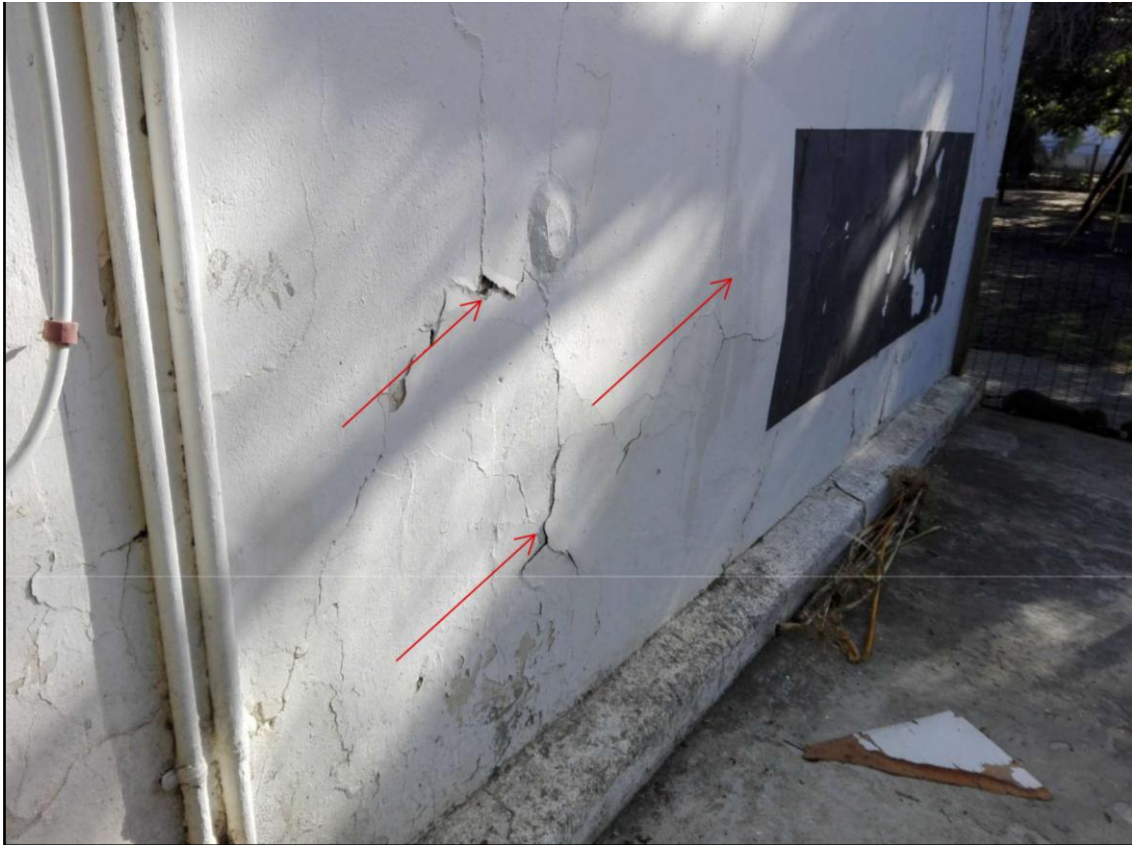
Figure 8. Plaster at northern end of building failing due to moisture seepage.

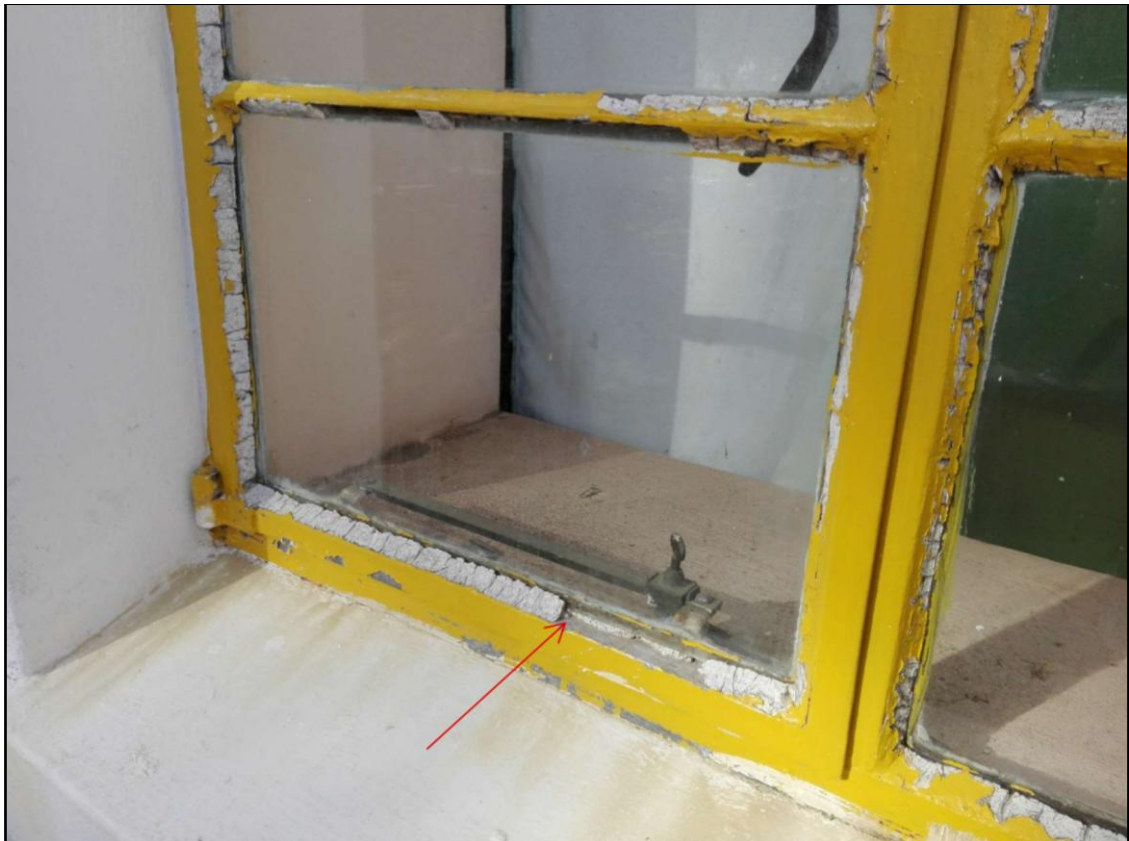
Figure 9. Metal frame windows in poor repair.

6. **Repainting of external structure and windows.** The exterior of the building will be repainted, and all windows will be repaired and repainted (Figure 9). Funds do not currently extend to replacement of the existing steel framed windows with timber, but should money come available that would be desirable.
